PROPERTY INSPECTION REPORT

Client:	Mr. Bill Smith
Client Address	2005 Kinsella Court, Kellyville. NSW
Contact Phone Number	0400 111 111
Contact Email	billsmith@hotmail.com
Report Number	9999
Property Inspection Address	1900 Chapel Lane, Baulkham Hills. NSW
Current Status	Vacant
Type of inspection	Pre Purchase Report with Pest opinion
Inspection Date	16 th August, 2012 12.30pm
Date of report	17 th August, 2012
Weather	Clear
Building Inspector	Michael Hadad

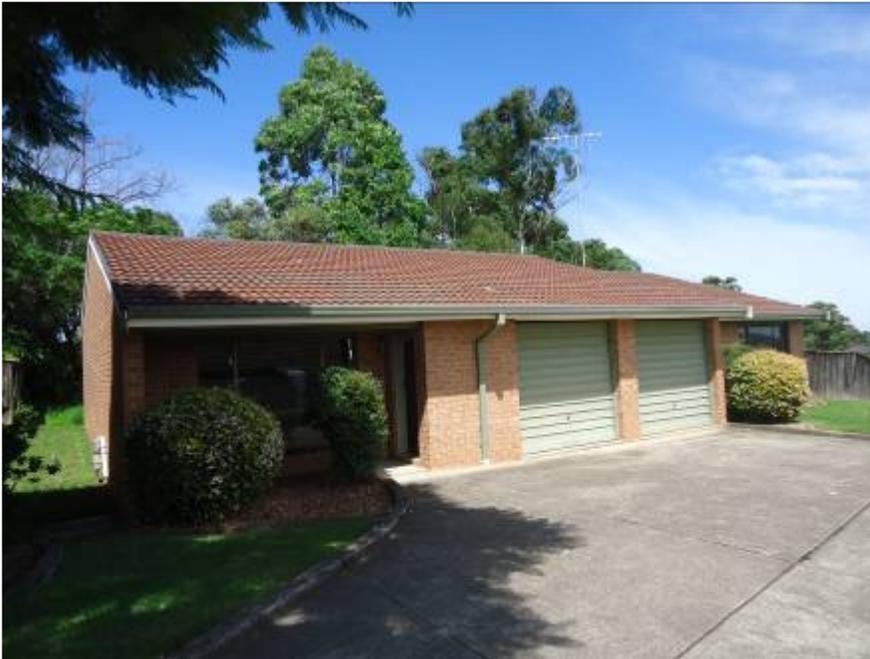
Photo 1 – External view of property

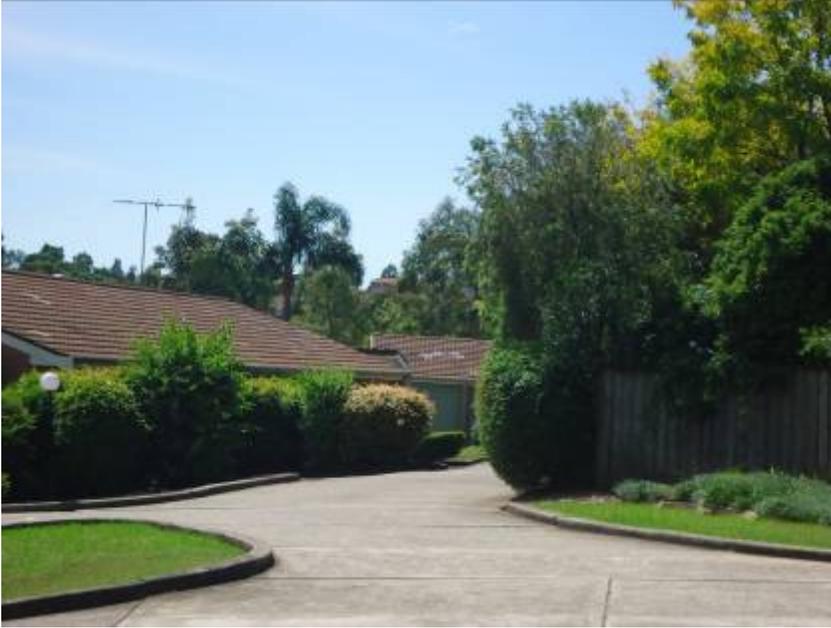
The said group of cluster homes has a good degree of advanced vegetation of which is well maintained.

Photo 2 – Showing vegetation and surrounds

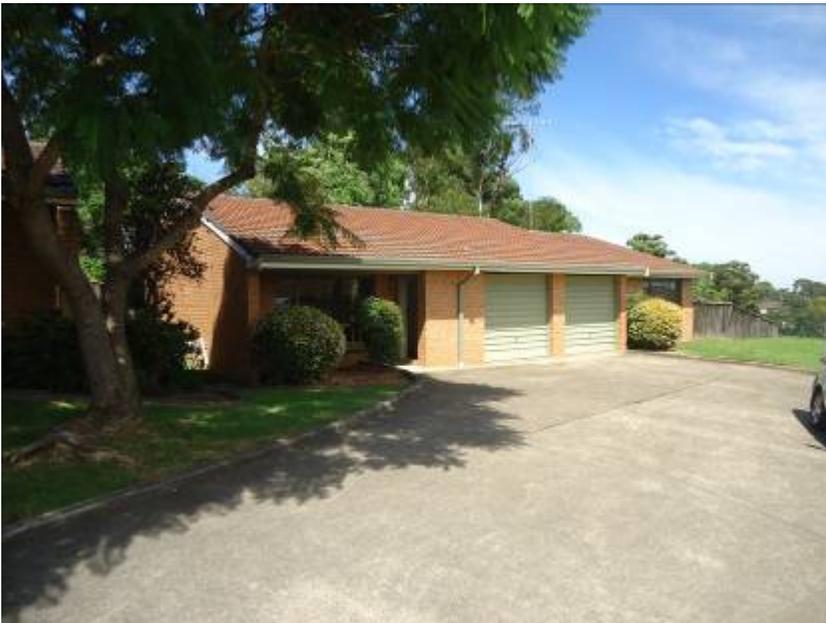
The structure of the house is of brick veneer exterior walls of which are adequate and quite sound with no major cracking or subsidence evident. With gyprock sheeting to the inside walls and ceiling, concrete slab to the floor, concrete roof tiles in good condition for the age of the villa, roof structure of timber trusses, aluminium windows and sliding doors.

Photo 3 – External surrounds

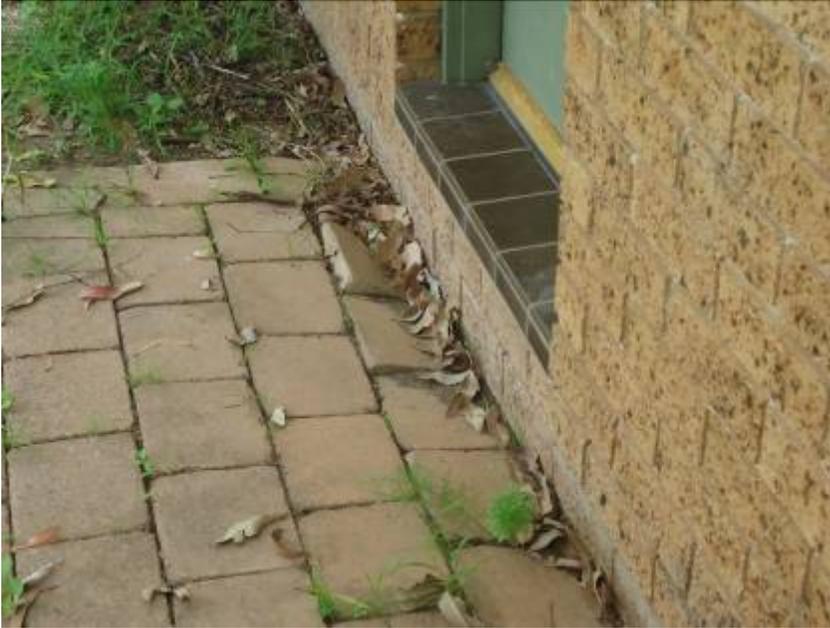
The paving to the rear of the property has subsidence in certain areas due to soil movement – rectification required.

Photo 4 – Distorted paving to back of property

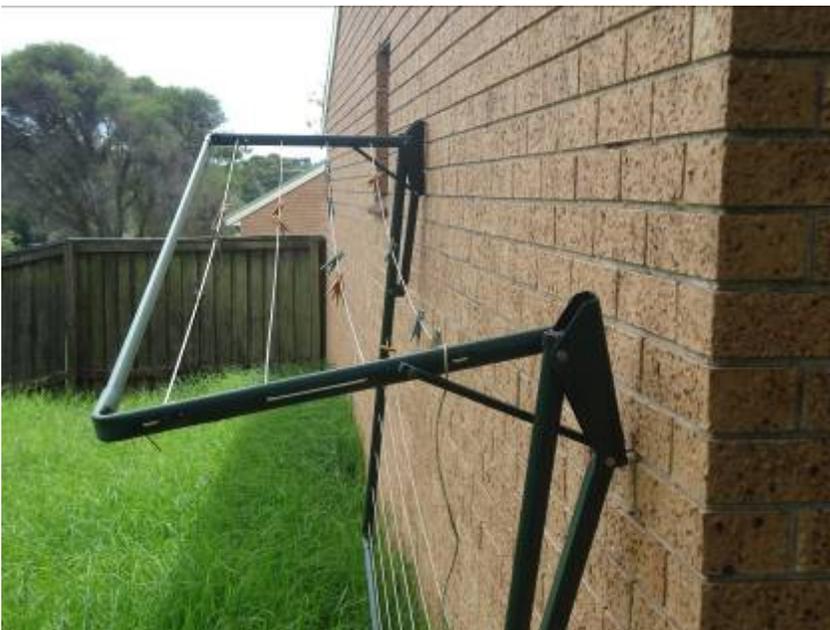
The clothes line that was affixed to the brickwork has come away from its fixings – rectification required.

Photo 5 – Clothes line requires re-fixing to wall

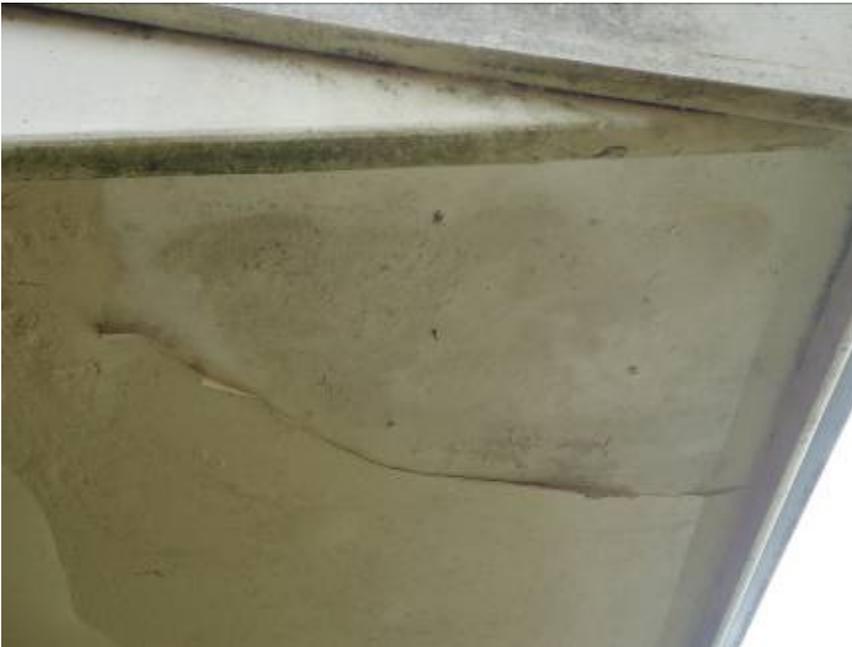
The fibro sheeting in certain areas, namely under the front verandah, are showing signs of water penetration through the blockage of the roofing gutters. I recommend the sheeting to the said eaves to be cleaned and painted – recommend rectification.

Photo 6 – Sheeting to eaves in poor condition

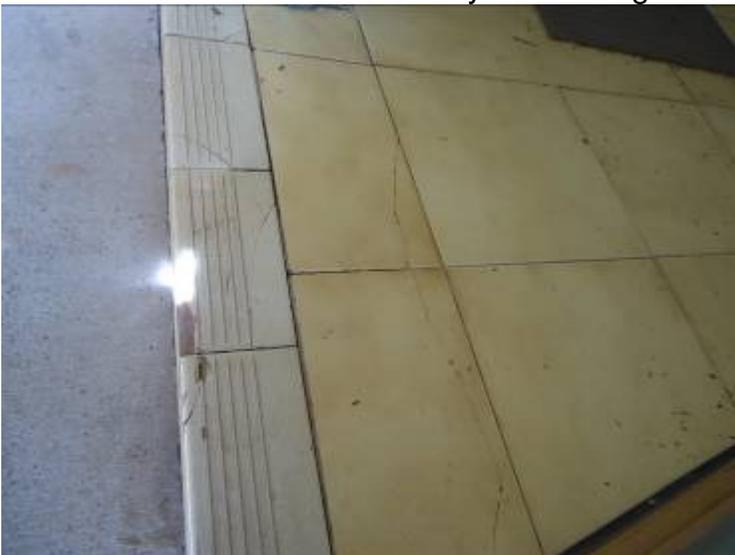
The ceramic tiles to the front entry have a degree of cracks and chipped tiles.

Photo 7 – Ceramic tiles – chipped and cracked

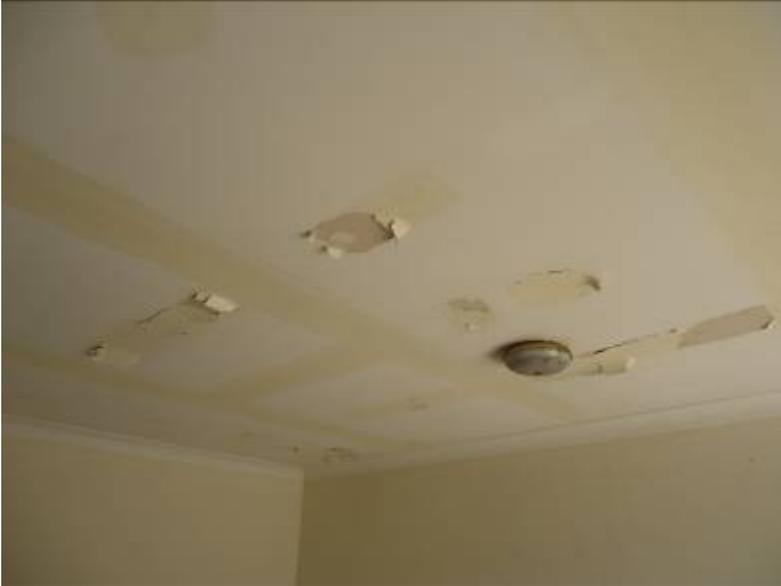
I suspect that, at some point previously, there may have been a degree of water penetration to the garage ceiling that has since been rectified. However, the paintwork to the area has not been re-applied properly and is peeling away. Therefore, the paint work will have to be scrapped back and removed and the area re-painted.

Photo 8 – Paintwork deteriorated to ceiling of Garage
